4. TITLE (and Subtitle) Phase I Inspection Report Clarks Mills Dam Upper Hudson River Basin, Washington County, NY Inventory No. 120		5. TYPE OF REPORT & PERIOD COVERED Phase I Inspection Report National Dam Safety Program

7. AUTHOR(s) <b>LEVEL</b> John B. Stetson		6. PERFORMING ORG. REPORT NUMBER
9. PERFORMING ORGANIZATION NAME AND ADDRESS Stetson-Dale Engineering Company Bankers Trust Building Utica, NY 13501		8. CONTRACT OR GRANT NUMBER(s) <b>✓</b> DACW-51-79-C-0001

14. MONITORING AGENCY NAME & ADDRESS (if different from Controlling Office) Department of the Army 26 Federal Plaza New York District, CofE New York, NY 10287		12. REPORT DATE 28 August 1980

PHASE I INSPECTION REPORT  
NATIONAL DAM SAFETY PROGRAM  
NAME OF DAM - CLARKS MILLS DAM ID# - NY 120

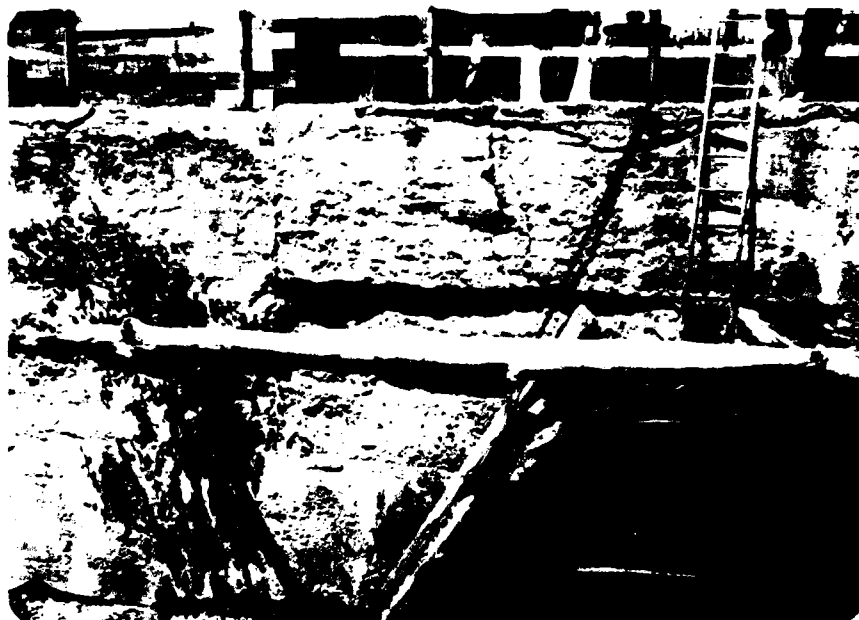
Leakage is occurring through the concrete into the core of the Northerly, Ambursen-Type-Section. Extensive deterioration has taken place at the north abutment and at the pier separating the two sections.

2. North abutment showing surface deterioration.

- (1) Eliminate leakage into the interior core of the dam and repair deteriorated concrete on the north abutment and at the pier separating the two sections of the dam.
  - (2) A formalized inspection program should be initiated to develop data on conditions and maintenance operations at the facility, etc.
  - (3) A flood warning and emergency evacuation plan should be developed and implemented to alert the public in the event conditions occur which could result in failure of the dam.
- X

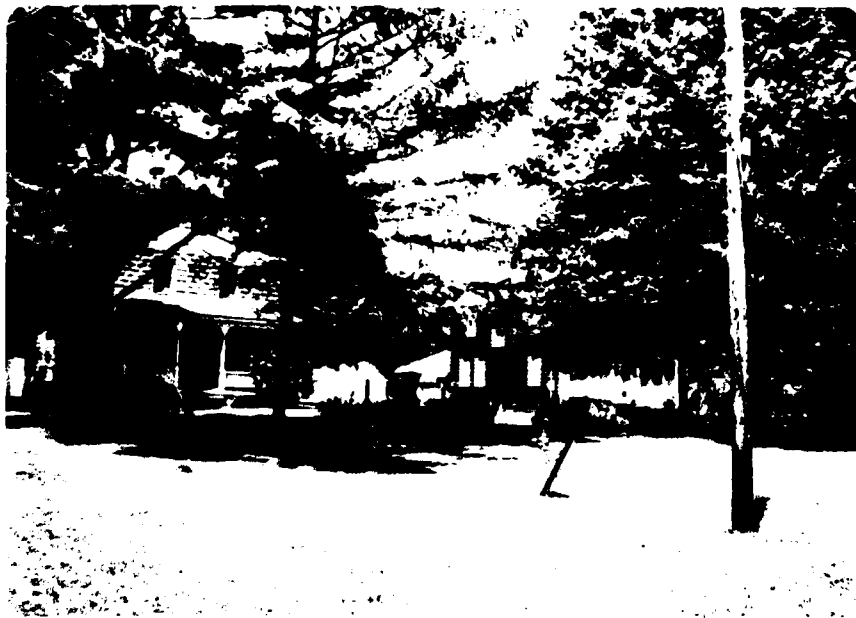
7. View of residences approximately  
11 feet above creek level just  
downstream from the dam.
